BEACH FRONT RESIDENCE, MARINO S.A

Project Description

Repair Solution

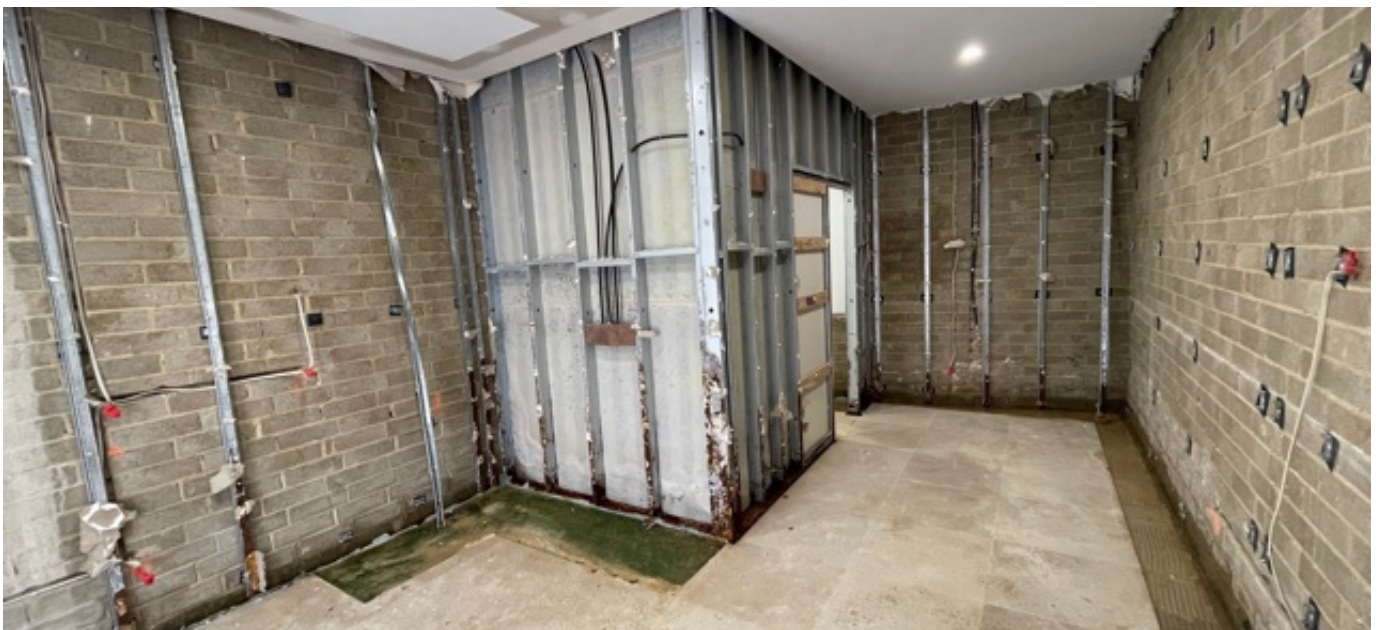
This beachfront home in South Australia was plagued with ongoing water ingress and mould to the lower level for over five years, with the owner engaging multiple professionals to solve the issue, with no success. The room was constructed with zero boundary to two adjoining properties which made for a challenging repair.

The structure is built with zero-boundary to two of the neighbours properties, meaning external excavation and repair was not a viable option - without partly demolishing the neighbours home as well. Water had entered continuously for several years causing complete soaking of the internal floors and walls, and extensive rusting of the metal framework.
